State of Utah
DEPARTMENT OF NATURAL RESOURCES
Division of Oil, Gas & Mining

Inspection Report
Minerals Regulatory Program
Report Date November 30, 2005

Mine Name: Golden and Lucky Chantz
Operator Name: Dan Shumway

Permit number: S/037/064
Inspection Date: October 6, 2004
Time: 10:00 AM to 12:45 PM

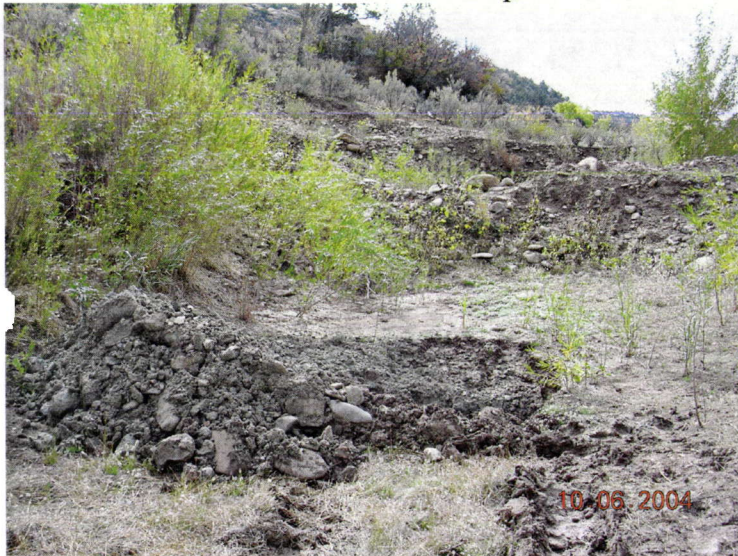
There were tracks in the road and a hole that had been recently dug, probably by a backhoe. The operator told me he had not done this work.

Photo 1. This shows the recently dug hole.

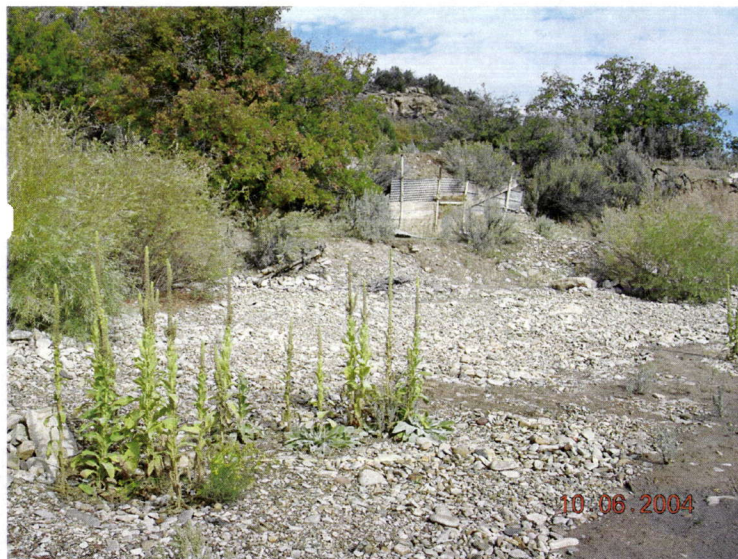
The northernmost of the sites is shown in Photos 1 through 4. As can be seen, the disturbed area consists basically of excavations into the alluvial material, but there is also what appears to be a small tippel (Photo 2). There is a test pit in the middle of the drainage.

Photo 2. A loading area within the upper area.

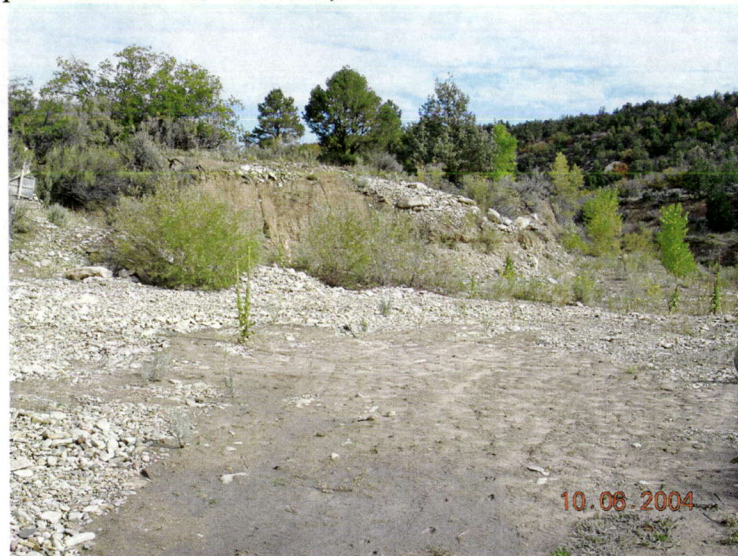
Photo 3. More of the disturbance in the upper area.

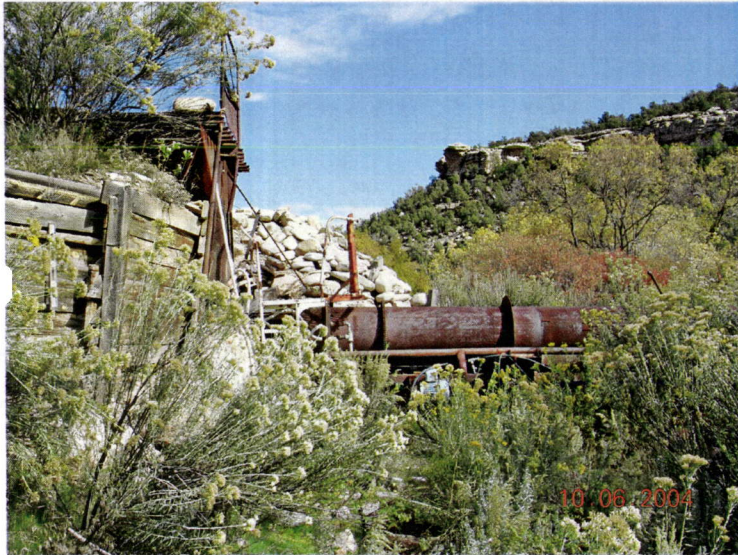
Photo 5. Some of the processing equipment in the wash area.

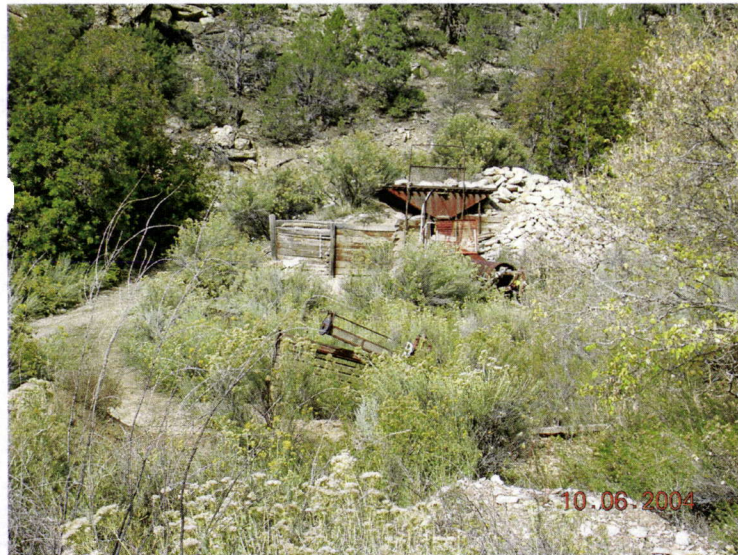
As far as I could see, the road ends at the lowermost of the areas which is the wash site, but the map shows the road continuing farther down canyon. The disturbed area and some of the equipment are shown in Photos 5 through 8. There is a small reservoir that was probably built to supply water for this operation, and there is a placer bar around the east and south sides of the area. The reservoir is not shown in any of the pictures, but it is to the right of Photo 6.

Photo 6. Another view of the equipment in Photo 5. The reservoir is right of this picture.

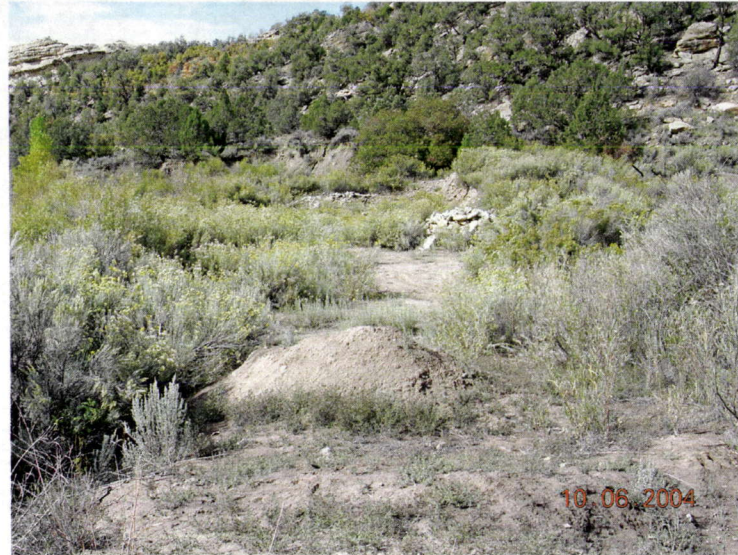
Photo 7. More of the disturbance in the lower (wash) area.

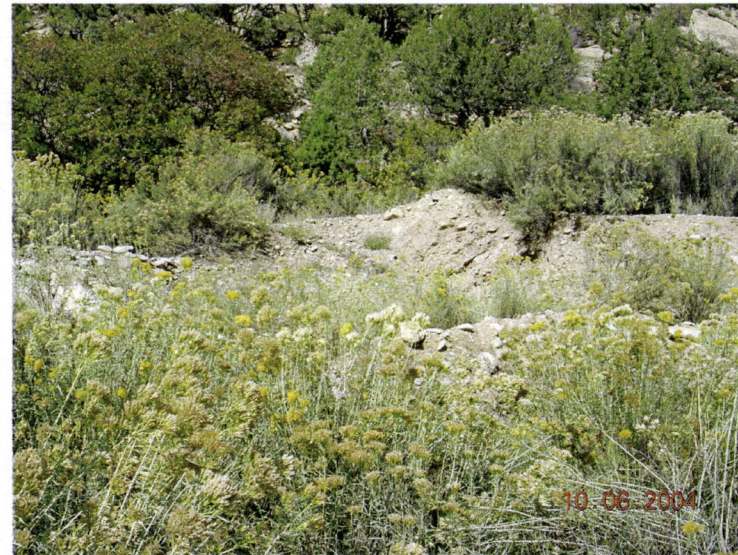
There is a lot of vegetation, especially rabbitbrush, at both sites, but particularly at the wash plant. Considering the location in or adjacent to the channel, this is not surprising.

Photo 8. This shows part of the placer bar. Note the amount of vegetation in all of the pictures.
